APPLICATION OF HIGH-RESOLUTION ACOUSTIC IMAGING FOR ADHESIVE BOND EVALUATION

Abstract: The quality of adhesive bond joints is characterized using acoustic methods and discussed in this paper. Acoustical images of basic types of defects in models and real industrial samples are represented. The material variety includes metal (steel, aluminium alloys, magnesium) bonded with epoxy-based structural adhesive. Three-dimensional data were obtained using an acoustic scanning microscope in the frequency range of 10-250 MHz. Additional digital signal processing was applied to reduce interfering reflections inside the jointed structure. Classification of defects is given according to their detectability. The advantages and main limitations of the acoustical imaging method are discussed. The acoustical data are proved by comparing them with destructive testing results. The discussed results assigned for quantitative estimation of quality of the adhesive joint to create requirements for development of specialized ultrasonic equipment.

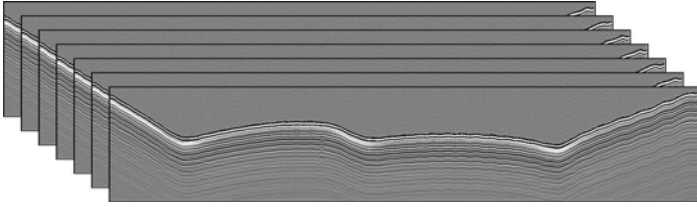
Fig. 1. Three-dimensional acoustical data.

Results and Discussion: Specimens for the experiments consist of two steel sheets with a thickness of 0.8-2 mm, joined by a 0.3 mm layer of the industrial structural epoxy adhesive. Images have been obtained on the Sonix HS-1000 and Tessonics AM-1103 acoustical microscopes. Both microscopes are able to produce three dimensional data with the capability for following data processing (Fig.1.).

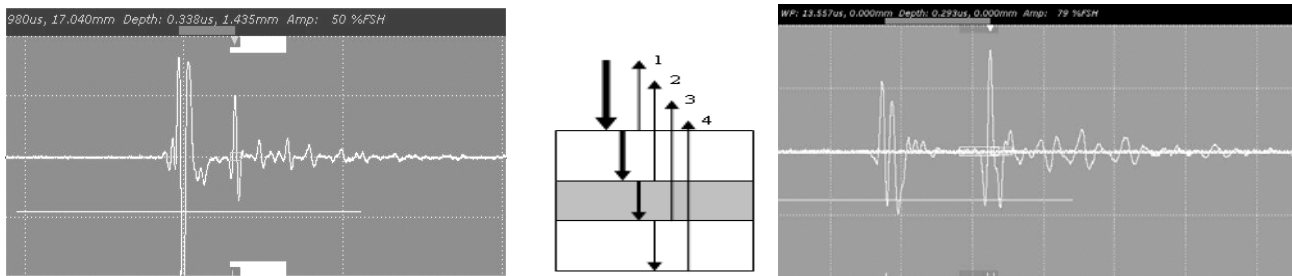
Fig. 2. The A-scan obtained on metal-epoxy-metal adhesive bonding for good quality adhesive (a) and aged adhesive (b). Focal point tuned to first interface. Pulses 1, 2 and 3 are reflected from corresponding interfaces; reflection from interface 4 is practically undetectable

Conventional ultrasound instruments employing the reflection of pulsed acoustic wave gives an A-scan in the form of damping series of the oscillations (Fig. 2). The pulse travels through the material which is under investigation and then the amplitude and position of the pulse are analyzed. The first and second pulses (signals 1 and 2) represent reflections from upper and lower surfaces of the metal sheet. The operational frequency should be high enough for the separation of these signals, and we found that the optimal frequency range for metal sheets with thickness of 0.8 – 2.0 mm is 10 – 50 MHz. Mapping of the second pulse's amplitude (C-scan) gives us an image of the interface conditions, voids and disbonding areas. This imaging method is the most sensitive to the changes in acoustic parameters of the adhesive layer.

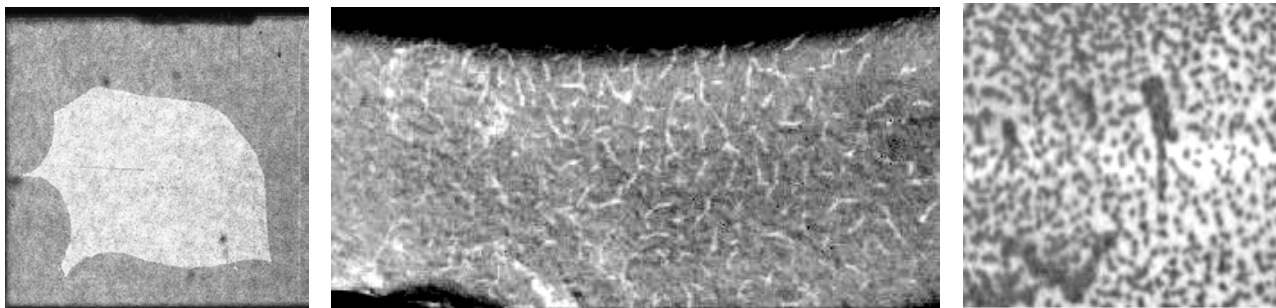
Fig. 3. Acoustical images of the voids (a), cracks (b), and porosity (c).

Absence of the adhesion is the easiest type of defect to detect with the acoustic method as there is considerable difference in the reflection coefficient for metal/air and metal/adhesion interfaces. Adhesion voids appear when adhesive is absent between two metal sheets (Fig. 3a). It can be identified in the image of metal/adhesive interface as a brighter area compared with adhesion presence. The main reason of adhesion absence is the surface roughness and improper surface preparation, which leads to air being trapped in the interface. Insufficient amount of the material can also cause this problem. Cracks on the interface weaken the adhesive strength and are usually caused by stress being applied (Fig. 3b). Porosity inside the adhesive layer is more efficiently detectable by focusing and mapping the lower adhesive/metal interface (Fig.3c). In this case, all pores appear as darker spots in the image as ultrasound totally is reflected from the pores, which are above the inspected interface.

acquire more information from A-scans and, therefore, significantly improve quality of the acoustical image. Resonance or cross-correlation methods achieve higher contrast in the acoustical images, which makes defects in the adhesive joints more detectable. This improves performance of the ultrasonic imaging method and gives more reliable basis for the evaluation of the industrial adhesive bond joints. Results of the destructive tests strongly confirm ultrasonic evaluation of the adhesive bond joints. Comparison of the images in Fig. 3a and 9a (adhesion void), 4a and 9b (adhesion problem due to Teflon), 6 and 9c (cohesion problem due to the aged adhesive) shows that acoustical images are in good correlation with the destructive test results. Study of the adhesive's microstructure also shows a correspondence between high resolution acoustical images and results of the destructive test. In the precured stage (Fig. 5a and 10a), adhesive has not developed its network structure yet and still remains in a glassy state, which is presented in the acoustical image. There is conformity between images with porosity inside the adhesive (Fig. 3c and 10b). Pore size measured by both methods is 0.2 mm.

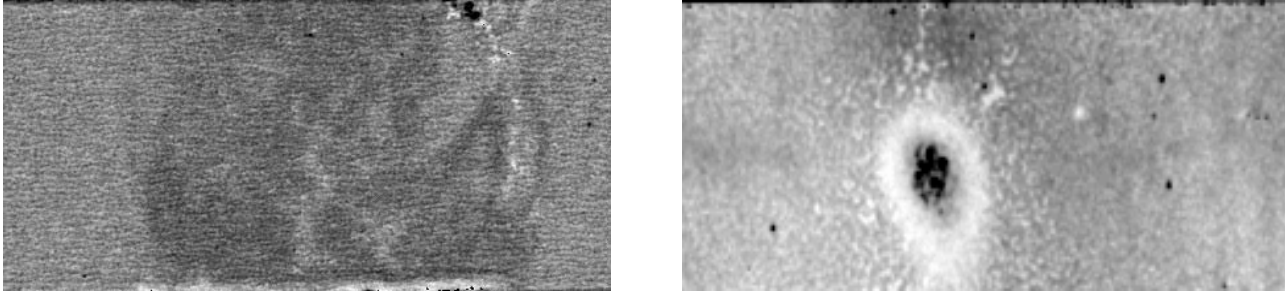
Fig. 4. Acoustical images of the adhesion problems caused by oil (b) and Teflon (a) presence on the interface.

Adhesion problems are usually caused by improper surface treatment or contaminant presence on the interface (so-called zero-volume unbond). They prevent adhesion to the substrate but unlike voids no air is trapped in the interface. Adhesion defects are the most complicated case for detection with acoustic technique, because the adhesive and substrate are in acoustic contact but no attractive forces between the substrate and adherent appear. A Teflon layer models the adhesion problems on the interface (Fig. 4a). In real manufacturing conditions, contamination of the substrate with grease or oil may cause poor adhesion appearance (Fig. 4b).

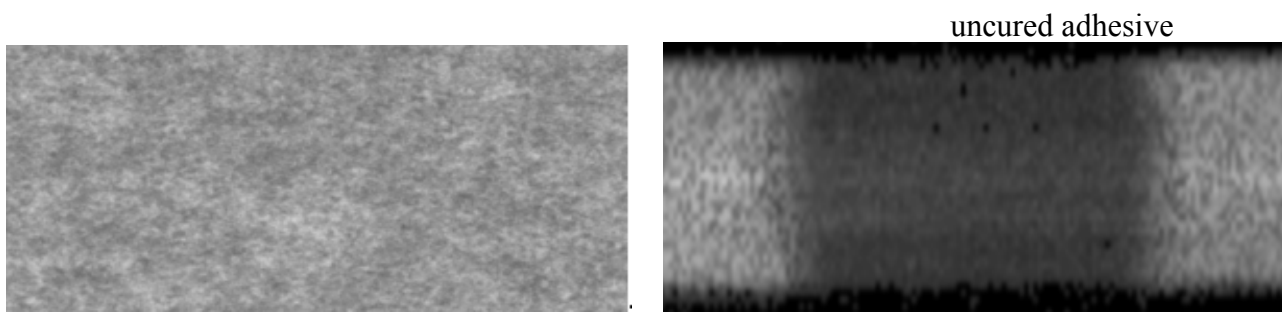
Fig. 5. Acoustical images of the microstructure of precured adhesive's interface (a), cured and uncured adhesive regions in transmission mode (b).

Poor cohesive strength is often a result of improper curing conditions: insufficient cure temperature or cure duration, improper adhesive resin/hardener ratio and others (Fig. 5). In this case, the substrate/adhesive interface shows undeveloped interface microstructure in the images where a high frequency acoustic lens was used (a). In the transmission mode, uncured regions are presented as darker areas due to a higher attenuation of the uncured material (b). To detect improper curing conditions, a higher acoustical frequency and resolution is usually for its detection usually needed.

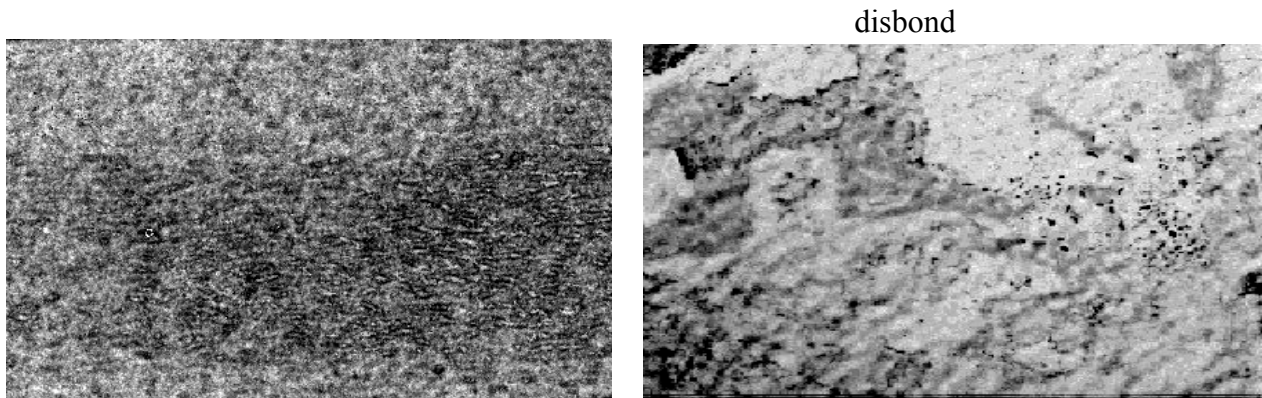
Fig. 6. Acoustical images of the adhesive exposed to the aggressive environmental conditions.

The result of aggressive media (high temperature, humidity and salt) exposure becomes apparent in an adhesive layer as some structure modification. This modification signifies a loss of strength due to the appearance of microcracks and microvoids in the adhesive volume as well as on the interface with the adherent. The reason of these defects is the penetration of the active substances through the adhesive's interface and thus changing the adhesive's structure on the interface and in the bulk of the joint. We found that the microstructure of the bulk adhesive has significant changes: it becomes globular with small microvoids (Fig.6a). Other authors also record formation of the microdefects in the aged adhesive samples [3, 4]. As exposure continues, disbonded areas show up and grow on the adhesive/substrate interface (Fig.6b).

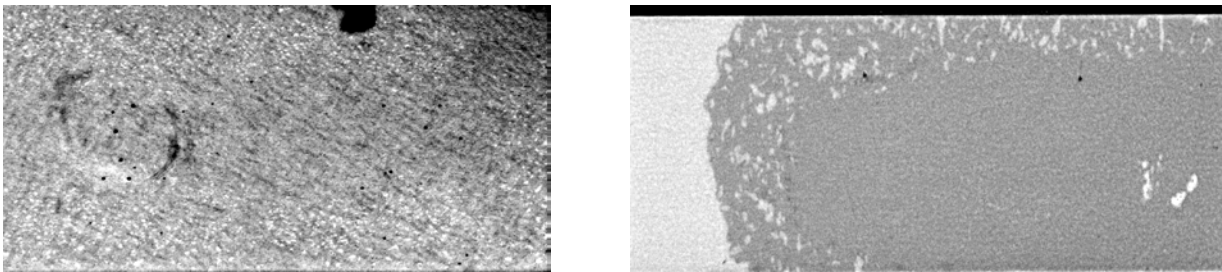
Fig. 7. Adhesive interface after uncured adhesive been exposed to water.

Cohesion problems can also be caused by exposure of the adhesive to high humidity conditions. The adhesive we used absorbs water very fast, which has a significant influence on the joint quality after the adhesive has been cured. Although the main problem of the adhesive's exposure to humid conditions is weak cohesive strength; this also has an influence on interface quality. Small voids 0.1 mm in diameter appear on the metal/adhesive interface (Fig. 7a). In the case of longer exposure microvoids merge forming a 'lace' like pattern along the edges (Fig. 7b).

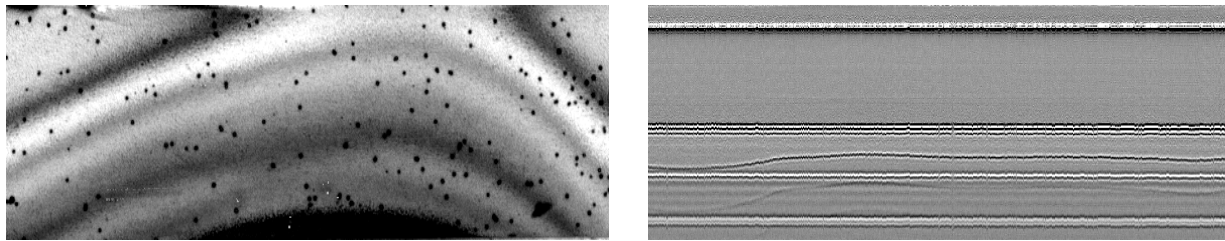
Fig. 8 . Acoustical monitoring of the adhesive thickness variations on C-scan (a) and B-scan (b).

It is known that adhesive joint's breaking force and stress depend on the thickness of the adhesive layer. Therefore, for achieving the desired joint strength it is important to maintain proper adhesive thickness through the whole joint. Adhesive thickness may vary because of insufficient or excessive amount of adhesive being applied on the substrate. Adhesive thickness variations can be detected acoustically on C-scan by mapping of the lower interface (Fig. 8a) or on vertical cross-sections (B-scan) (Fig. 8b). C-scans of the adhesive joint with variations of the adhesive's thickness usually show the interference pattern. Because of high ultrasound attenuation in the adhesive material, the reflection signal from the lower adhesive interface is very small and often difficult to find. Thickness of the adhesive layer should be not more than 0.5-0.7 mm. The signal can also be overlapped by reverberations inside the metal sheet. For that reason, metal/adhesive thickness ratio is also important for proper image quality. On B-scan of the sample with variable adhesive thickness, pulse reflected from the lower interface is visible as an inclined line, crossing the parallel lines of stable sheet reflections.

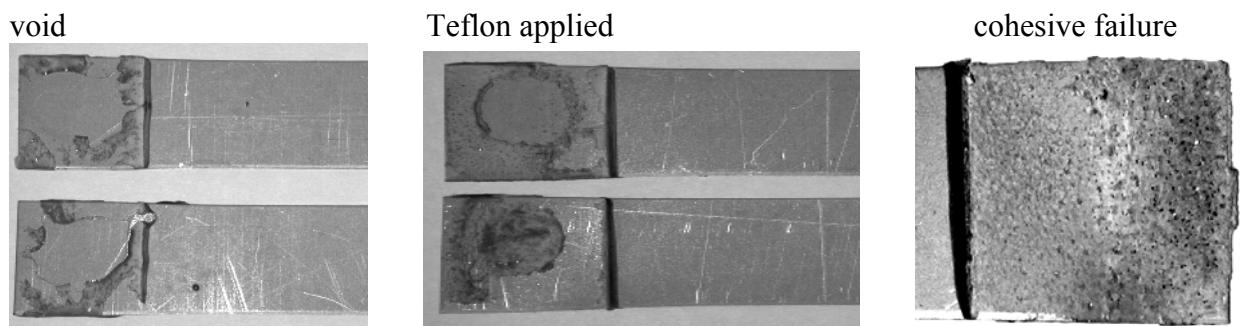
Fig. 9. Destructive test results. a-adhesive void, b-adhesion defects caused by Teflon layer applied on the substrate, c-cohesion failure due to adhesive's exposure to the aggressive environment

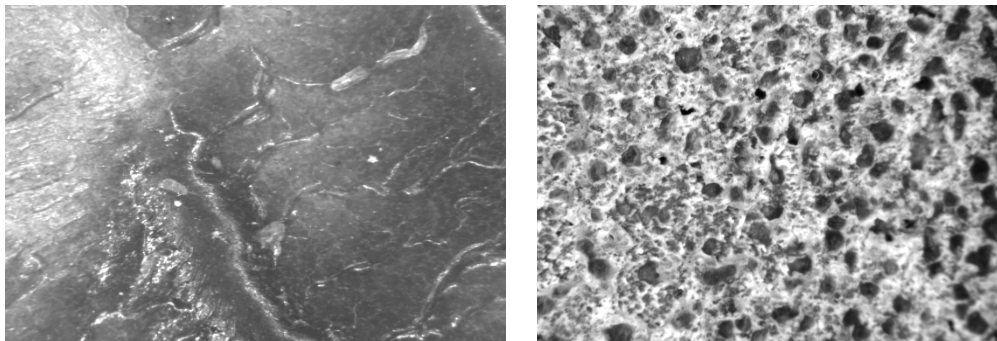
Fig. 10. Images of the adhesive's microstructure. Destructive test. a- precured adhesive, b-porosity inside the adhesive.
